FOUNDATION INSPECTION REPORT

2/13/19

Report Date: 2-13-19

Subject: Foundation Inspection

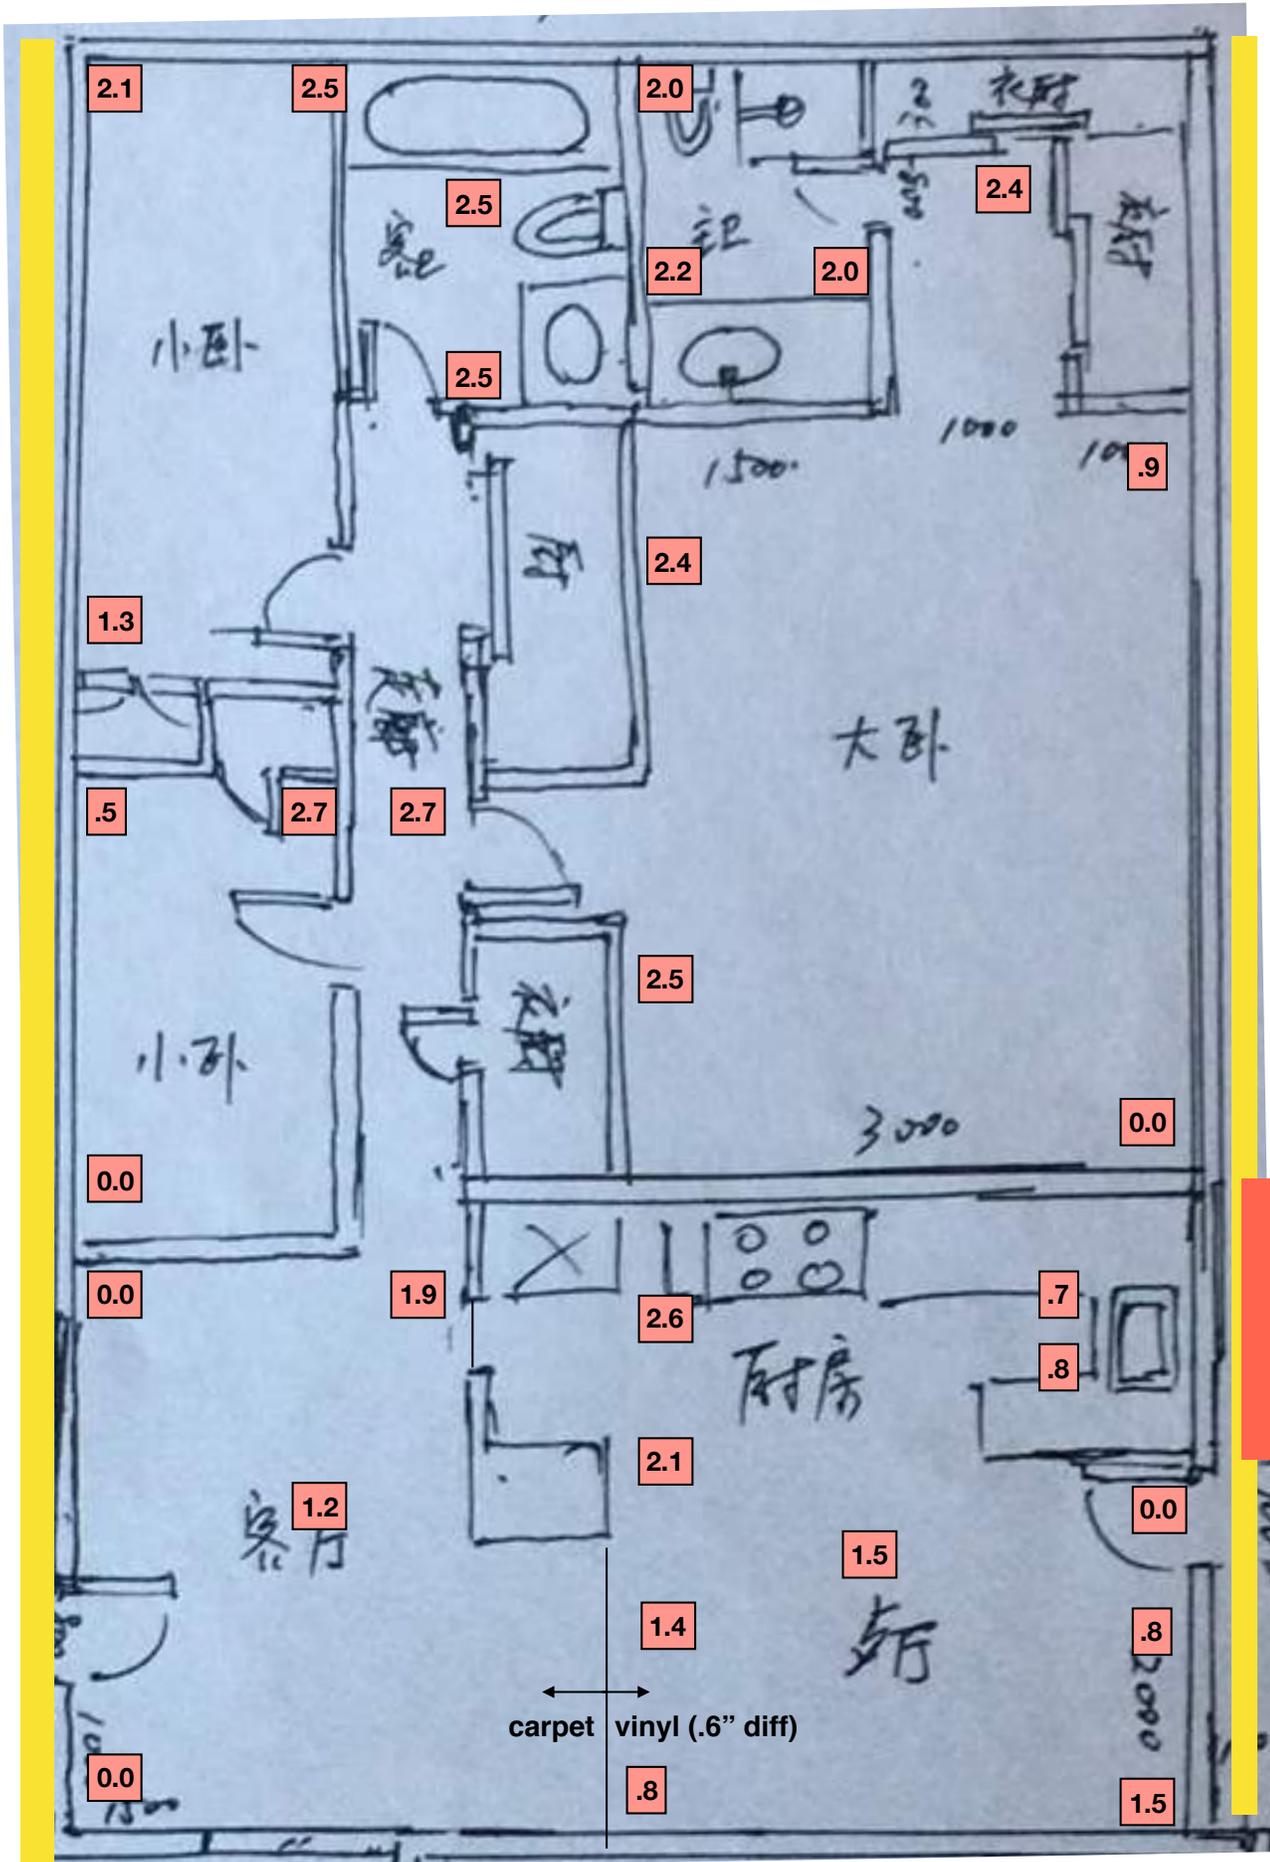
Floor Elevation Spot Check Results

- We took representative floor elevations readings with a Zipline manometer and the key results are shown in the preceding page. Overall there is a high point along the center of the house with a slope towards the outer edges along with a slope from the back of the house towards the front.

- This degree and direction of movement is not uncommon and relates to the expansive nature of the soils in this area and seasonal water fluctuations (See Appendix 3 for a further discussion of possible causes of movement). These conditions are likely present, to some degree, in other houses of similar design in the area.

- Most of the movement the house will experience has likely happened, i.e. it's unlikely to drop another 2" on the ends and the movement measured has likely been in the past because we do not see any sizable cracks in the house. We do however see some small cracks that have opened up since the last painting and it is possible some of them will change with seasonal fluctuations so the movement is active to some degree - a full soils report would be necessary to analyze further.

- The most feasible way to fully stop any future movement would be the underpinning of the foundation to support the foundation on deeper and more stable soils (or rock) below but drainage improvements will also assist and sometimes those are undertaken first and then monitor for future movement, in the case of the kitchen the drainage in that area is already good.

- Option A: The kitchen area is of higher priority so if this area were stabilized the cost may be in the \$8K range (+/- 20%) - Area A (see illustration on preceding page). The kitchen is the most noticeable because of the cabinetry and the other rooms are less noticeable - this would be of higher priority for stabilization given the nature of how a kitchen is used.

- Option B: If it were the whole house, going along the long sides of the house where the greatest movement is occurring, it would be in the \$60K range (rough budgetary pricing for local foundation underpinning companies is roughly in the \$750-\$900/linear ft range and that includes permitting and engineering but they must look at each job case by case to provide a detailed quote with economies of scale for larger areas).

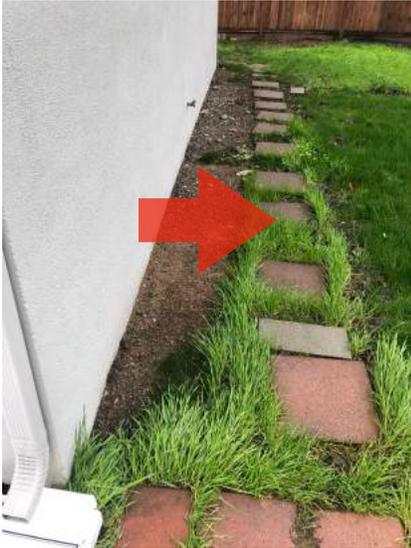
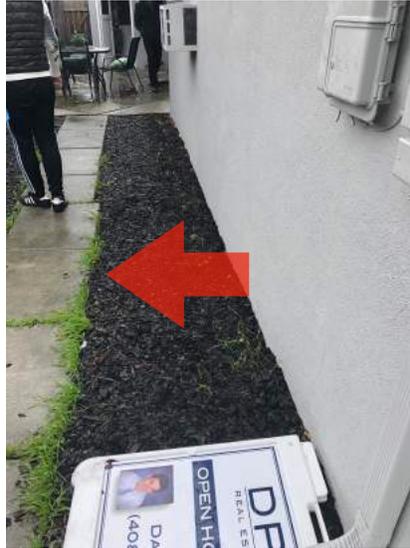
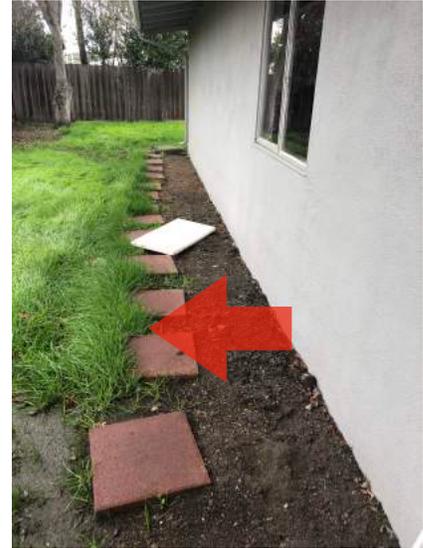
Condition #2 - Drainage Improvement Opportunities

- As with most structures of this age and area, the structure was not designed and built with exterior drainage upgrades. We recommend a proactive approach to the drainage conditions noted and in general it is recommend collecting and diverting excess water at the exterior of the structure before the excess water can affect the foundation and supporting soils of the foundation

- In some areas, there is a slight negative grade where the slope is flat or slightly back towards the house and the exterior grounds should be re-graded so that surface water flows more efficiently downward and away from the structured ideally, the areas shown above should have a concrete walkway poured to slope away from the structure to further the distance from where water is absorbing next to the foundation (see Attachment 2).

- All gutter downspouts should extend at least 5' from the house and discharge to a point that will flow away from the house.

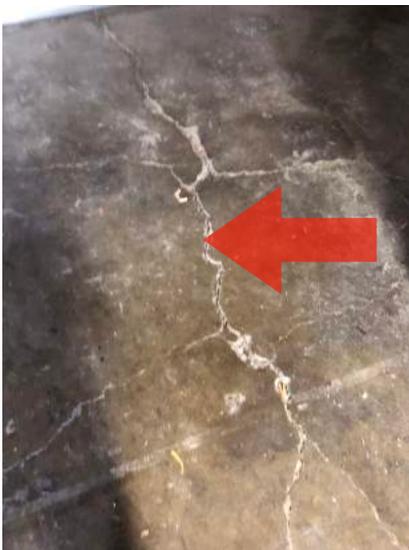
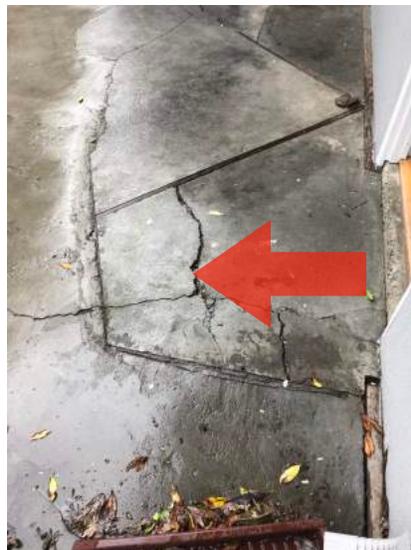
Condition #3 - Typical cracking of concrete garage & exterior concrete slabs

- For the garage, this is typical and relatively minor concrete cracking especially when expansion/control joints are not present, not of a structural concern and not related to the house foundation
- For the exterior patio, there may not have been adequate reinforcing steel installed and/or poor compaction/subsurface preparation but it is not of structural concern for the house and could be patched for the time being and eventually replaced or resurfaced as desired.
